CONSTRUCTION REPORT

SECOR INTERNATIONAL INC.
SPRINGFIELD, ILLINOIS

PATRICK
ENGINEERING INC.

SEPTEMBER 2006

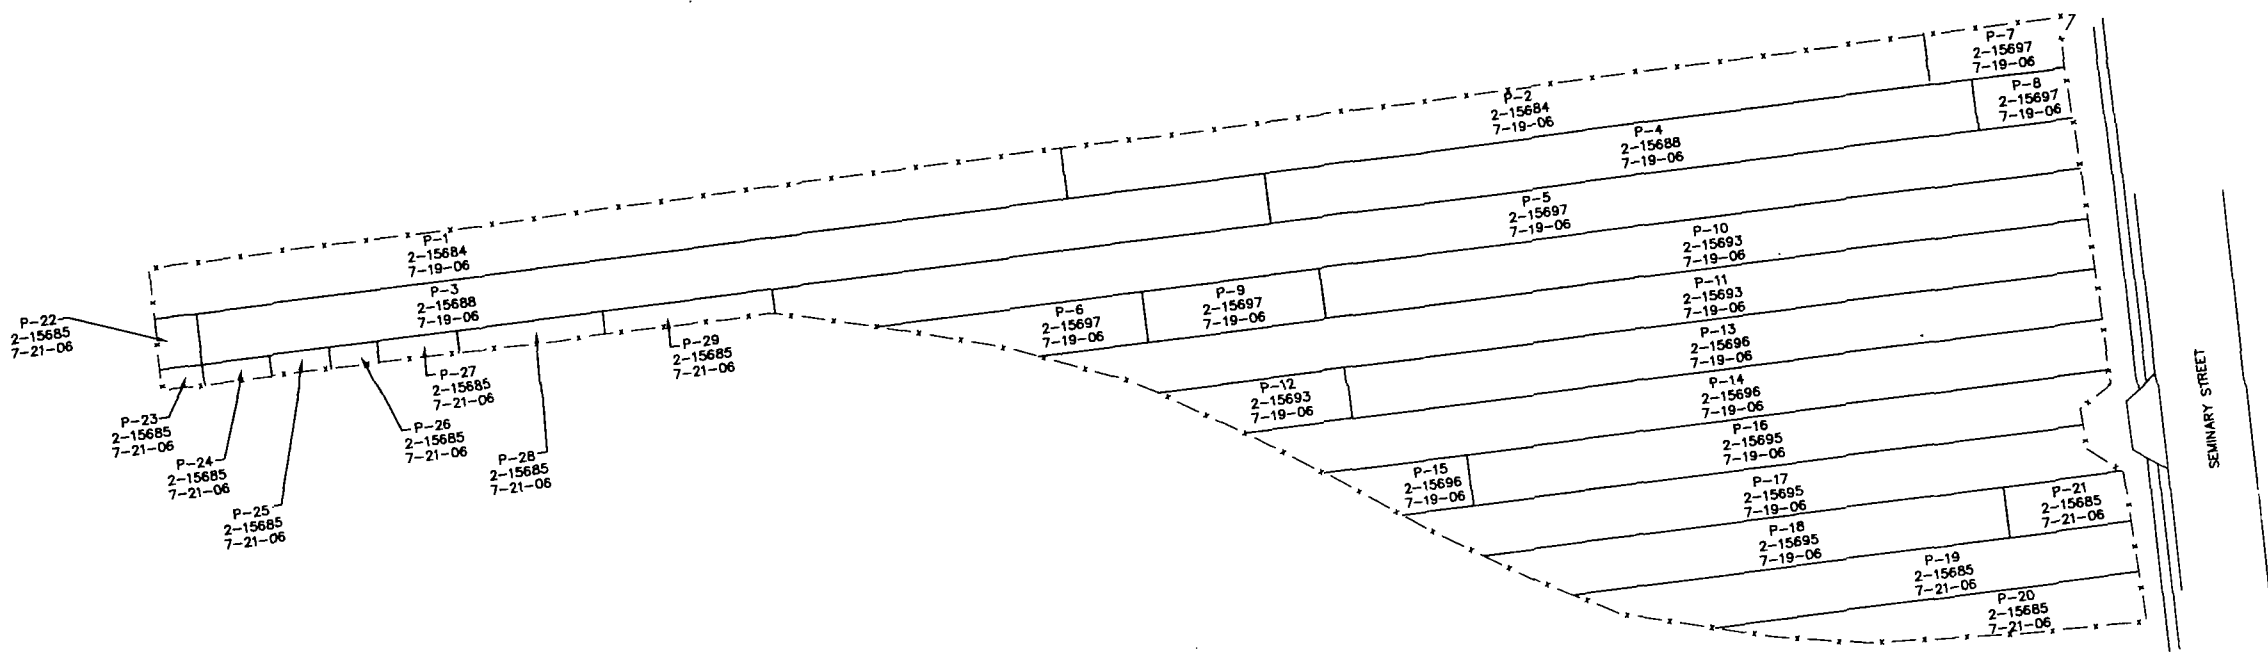
FIGURE 1

Method of Construction. A 40-mil HDPE was used for the FML, which was placed over the subgrade. The panels were deployed onto the subgrade with the orientation as shown in Figure 1. Rolls of the geomembrane were deployed with the use of a rubber tire tractor with forks to hold the spreader bar. An ATV and workers were used to position the panels to the proper location and overlap. The rolls were pulled tight to remove wrinkles and sandbags were used to secure the panel until seaming took place.
